LEVEL 2 REPLACEMENT RESERVE REPORT FY 2024 TIMBERLAKE COMMUNITY ASSOCIATION

REPLACEMENT RESERVE REPORT

TIMBERLAKE COMMUNITY ASSOCIATION

VIRGINIA BEACH, VIRGINIA

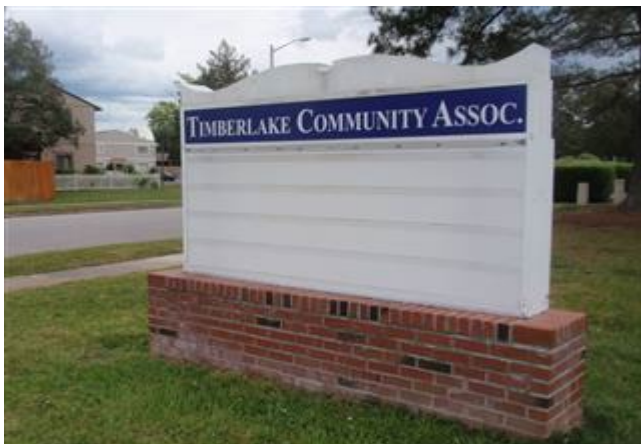
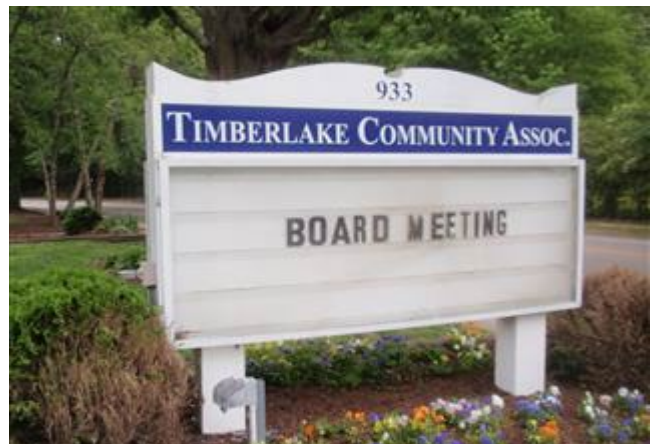
Entry Monument and Signage Marquee. The community has two marquee-style signs with backlighting panels for interchangeable messages. The Windsor Oaks Boulevard Club House has a single marquee sign that is in mixed overall condition. The brick base is in fair condition. One side of the marquee has a damaged panel which was identified in the 2020 study and has not been replaced. These signs can have an indefinite life if properly maintained and occasionally refurbished. However, at some point, a full replacement is usually necessary. The marquee at the Foxwood Drive Recreation area is in fair overall condition with some apparent age related deterioration.

We recommend repointing and replacement of defective areas of the masonry as needed. The Association may want to consider applying a coating of Siloxane or other appropriate breathable sealants to mitigate water penetration and further degradation of the masonry work.

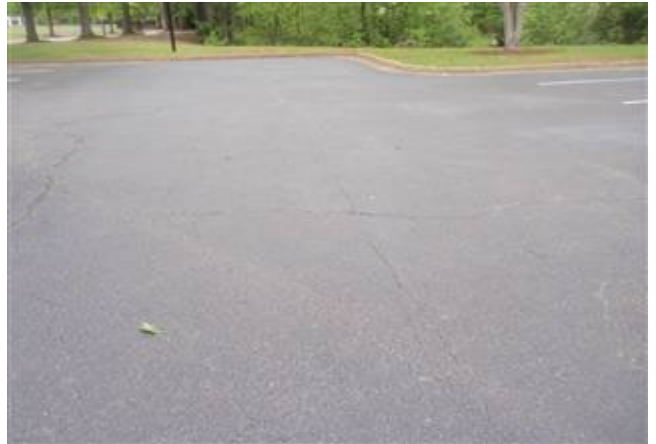
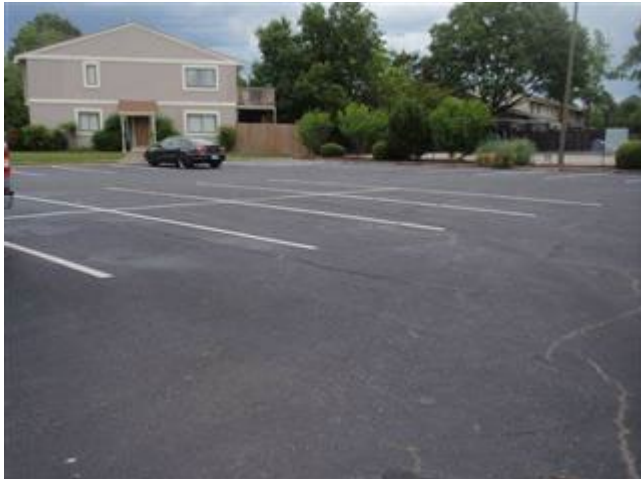
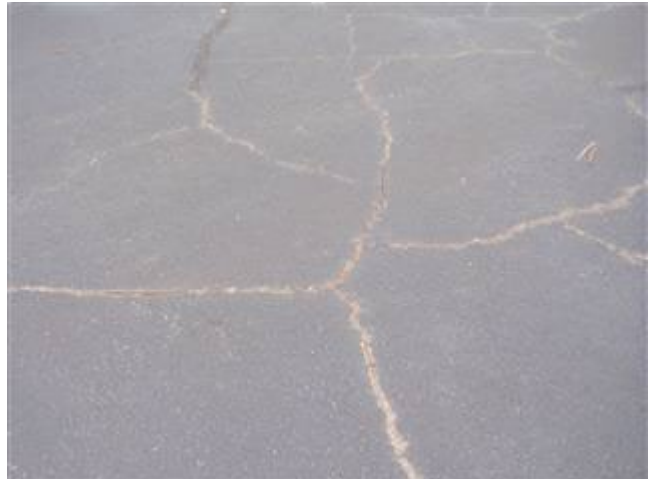
In general, the Association's asphalt pavements are in marginal to poor condition with little evidence of crack filling or seal coating performed since 2013. Crack filling and seal coating should be performed in 2021 to obtain any remaining economic life. However, this will not increase the normal or remaining life. There is a significant amount of asphalt path in portions of the community. These paths display areas of significant deterioration to include, including tree root damage, cracks, depressions, and potholes which could pose trip hazards.

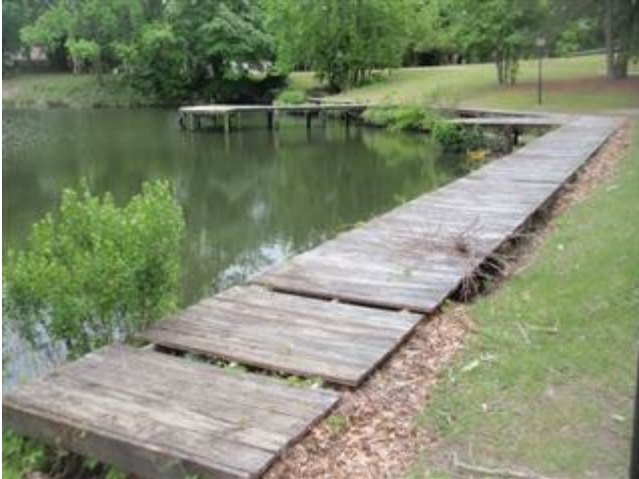
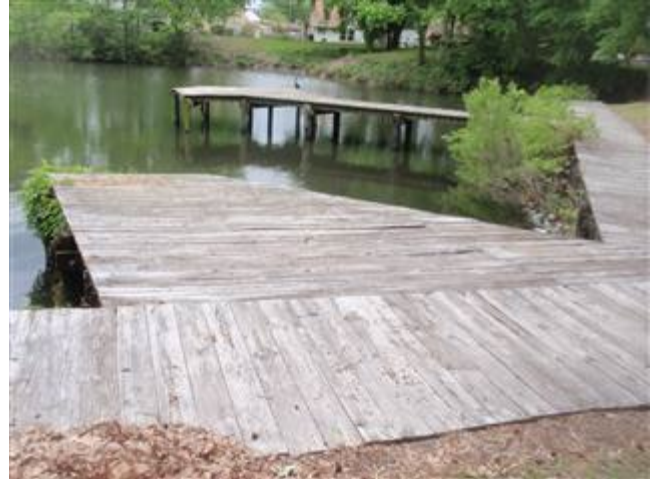
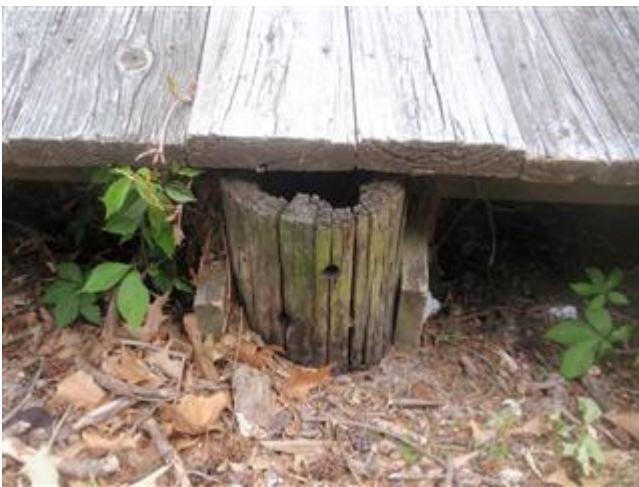
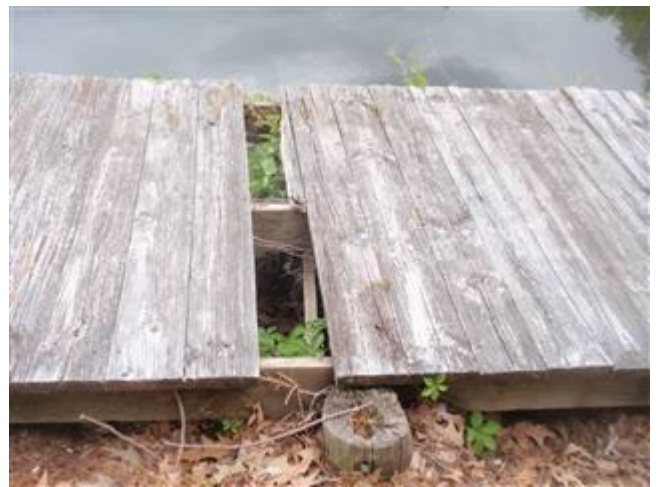
Fishing Pier. The existing fishing pier is a pile supported structure that shows significant age and deterioration of the piles and bents that support the actual decking and a large amount of the decking is missing or rotted. There appear to be remnants of caution tape in some locations but the majority of the pier is not protected with barricades and signage. This currently poses a significant safety concern. The previous Manager (2020) indicated that the entire structure was to be replaced in the following year but this was not done. The previous Manager reported the entire cost of the project was approx. \$30,000, but this is believed to be entirely inadequate for the extent of work in addition to the last 2-3 years of inflation. The inventory has been revised to reflect the proposed three major elements of the replacement including;

The current replacement costs are based on the mobilization of equipment for full replacement including the pilings and bents, all framing members, and all decking using marine-grade lumber and galvanized hardware for all bolted connections and stainless steel deck screws. This project will likely require a new survey to be able to obtain the permits. The cost of the survey and any necessary engineering for the drawings is not included in the replacement costs.

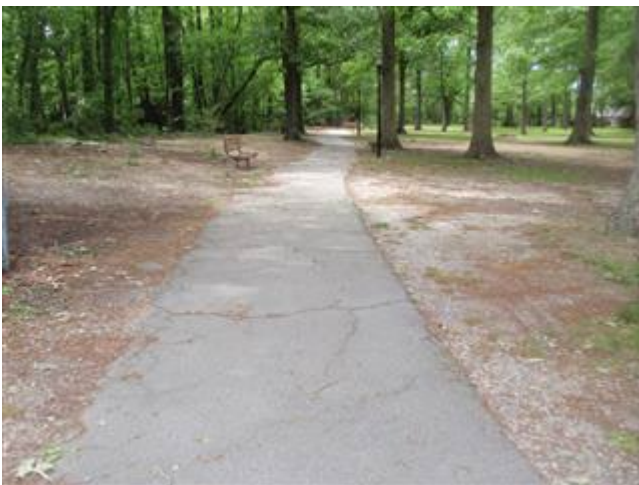
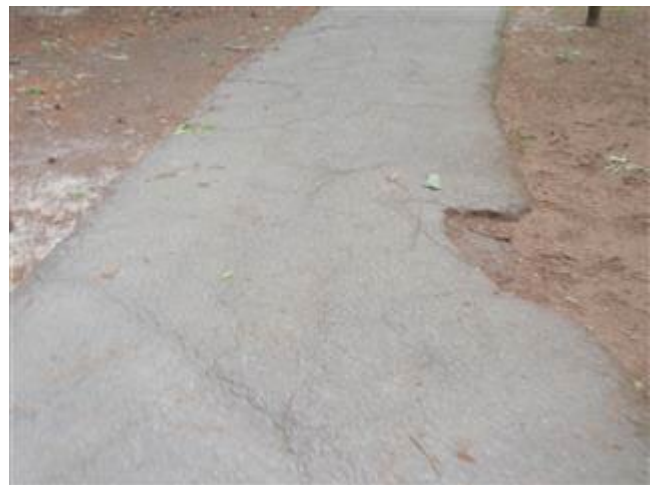
Asphalt Paths. The Association is responsible for the paths throughout the Foxwood Recreation Area. The paths appear to be in mixed condition with different levels of deterioration and trip hazards located throughout.

Asphalt paths are typically constructed on native soil. As a result, defects can begin to develop in a few years, leading to costly repairs, early replacement, and tripping hazards. Additionally, paths typically do not have proper edge confinement and support resulting in longitudinal cracking along the edges of the path. Compacted soil or gravel along the edges of the path can mitigate this problem. Lastly, tree root damage is a common issue with asphalt paths, and some communities have had success with a process called root trimming.

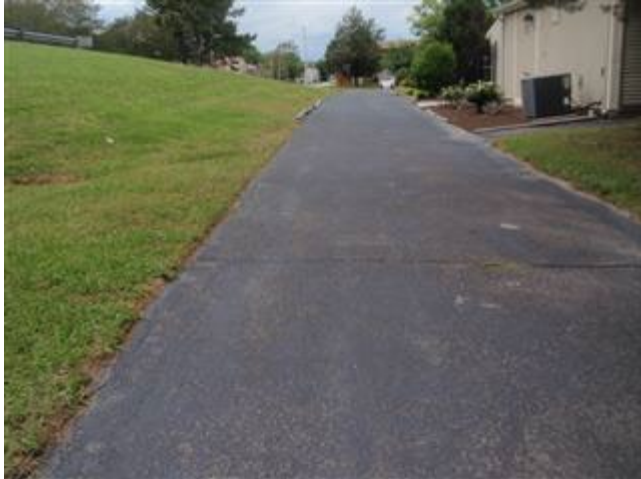
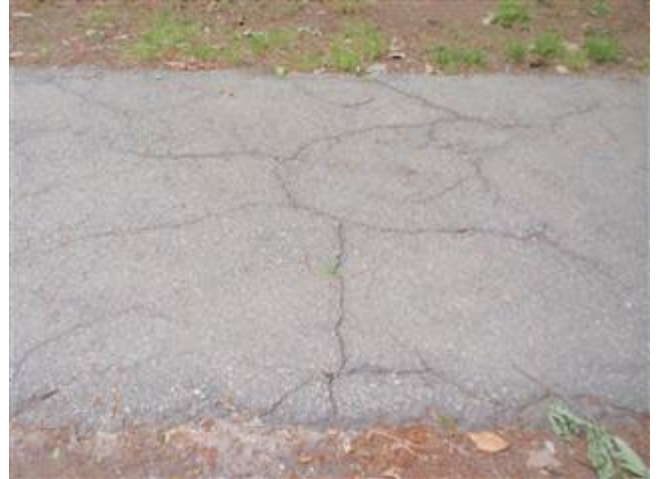
As a rule of thumb, asphalt should be overlaid when approximately 5% of the surface area is cracked or otherwise deteriorated.

To maintain the condition of the pavement throughout the community and to ensure the longest life of the asphalt, we recommend a systematic and comprehensive maintenance program that includes:

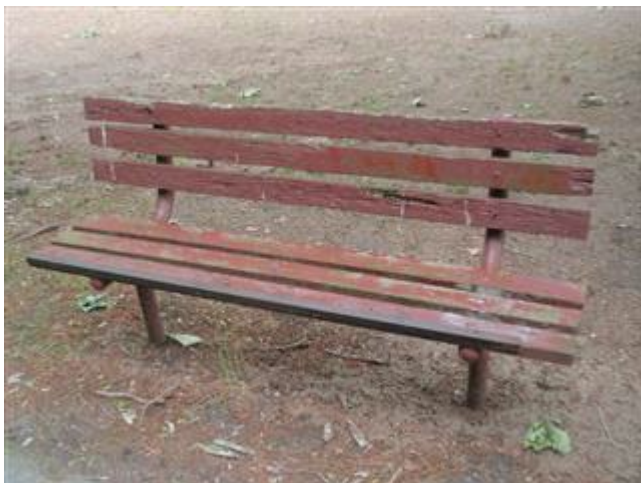
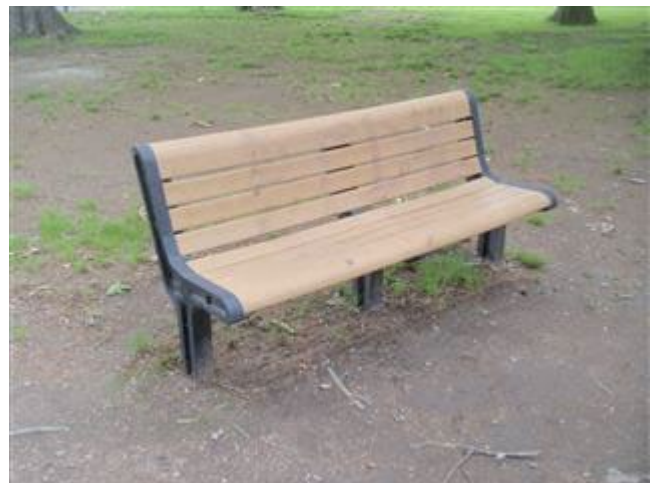
Reserve studies are not intended to be safety inspections but it is apparent that the concerns mentioned in the last update (2020) have not been addressed.

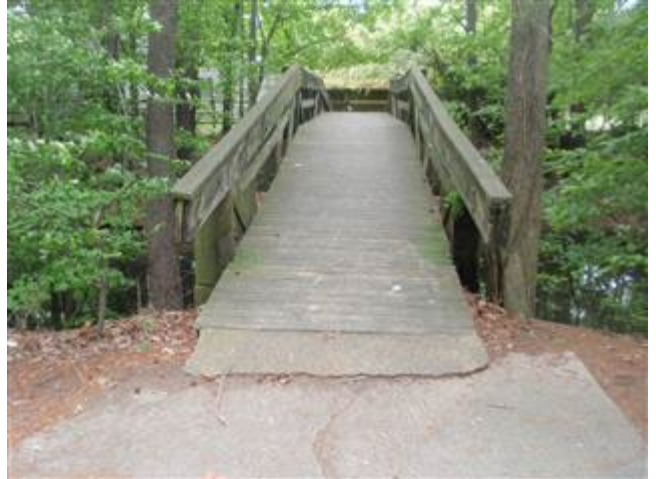
Wooden Footbridge. The Foxwood Recreation Area picnic area has a wooden footbridge across one of the drainage canals. This bridge is approximately six feet wide by 70 feet in length and is constructed with timber piles and pressure treated lumber for the framing, decking, and rails. This footbridge is in varied condition with evidence of previous repairs and partial railing alterations believed to improve fall protection. The overall age and condition of the footbridge indicate it should require the replacement of railings and decking within the next few years. The current condition of several framing members, decking boards, and railings is in very poor condition and could have sudden failure leading to personal injury.

A thorough structural engineer examination and evaluation of the footbridge is recommended prior to undertaking any deck or railing replacement to ensure the sub-structure can provide remaining economic life. We have included the replacement of the bridge in three primary categories; the railings, the decking, and the substructure based on different normal economic life expectancies. The Association may wish to consider a prefabricated simple span bridge for future replacement.

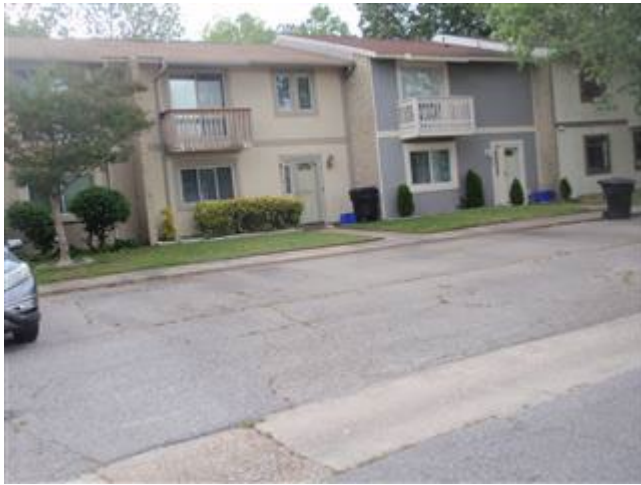
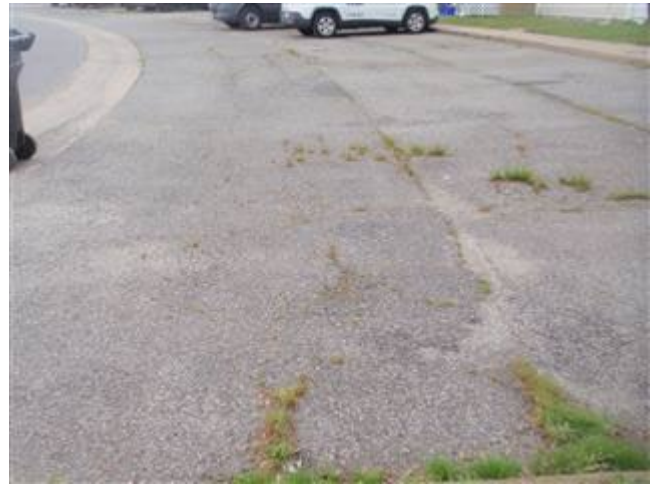
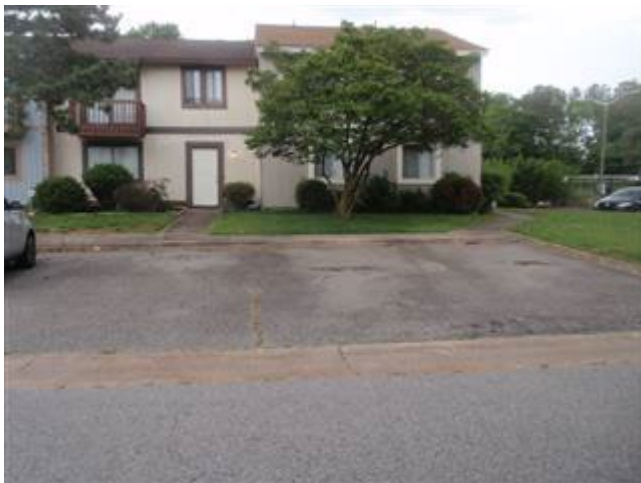
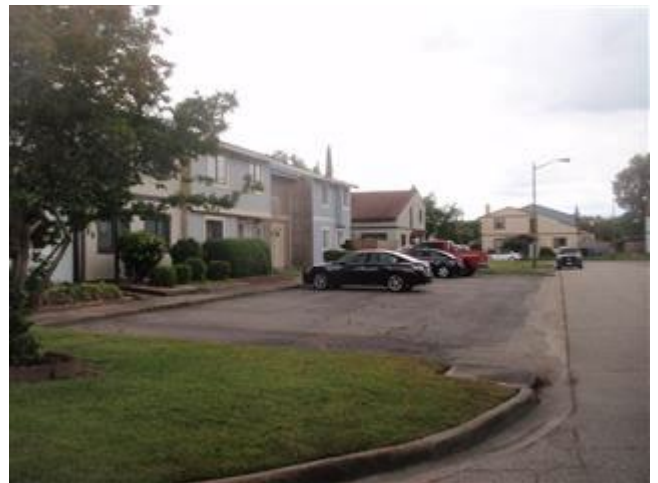
Townhome Parking Areas. The townhomes are located on public streets as verified with the City of Virginia Public Works, but the parking spaces for the townhomes are considered private pavement. The Association and Manager directed these asphalt pavement quantities be added to the inventory for this update. The area quantities for each location are based on the use of satellite imagery for width and length. The remaining economic life is shown to be phased for purposes of replacement. It is assumed the actual priority will be determined by the Association as these are all in roughly the same condition and the same age. It is apparent that crack filling and seal coating have not been routinely performed over the past 30+ years.

As these pavements are strictly for parking and are not subject to heavy traffic, a 30-year normal life is possible with proper milling and overlay thickness followed by regular cleaning and seal coating.

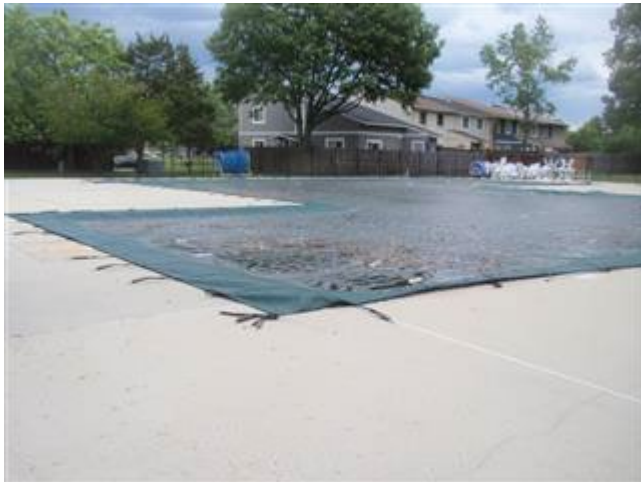
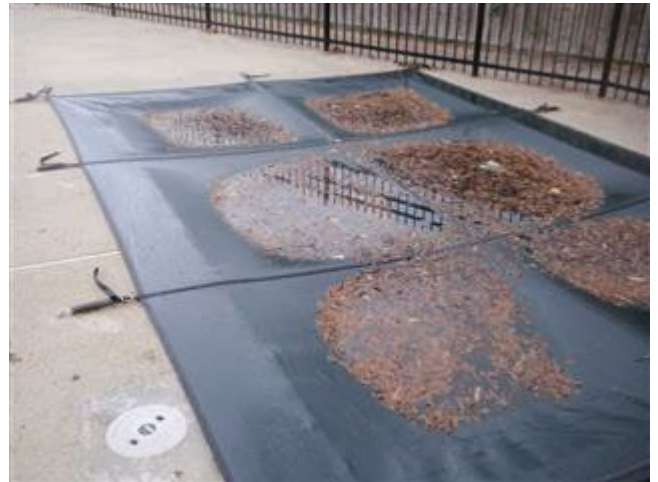
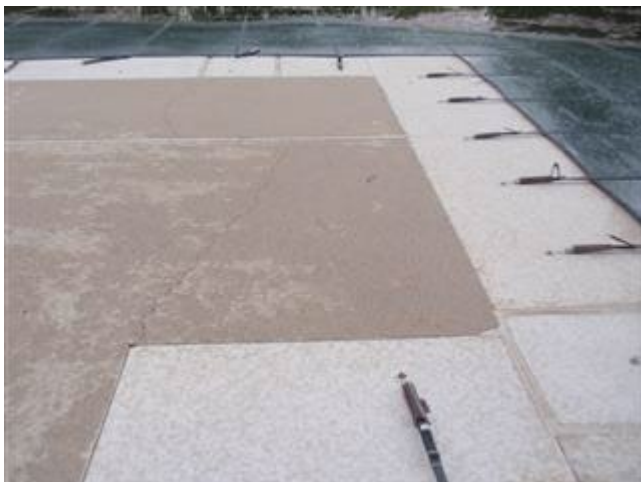
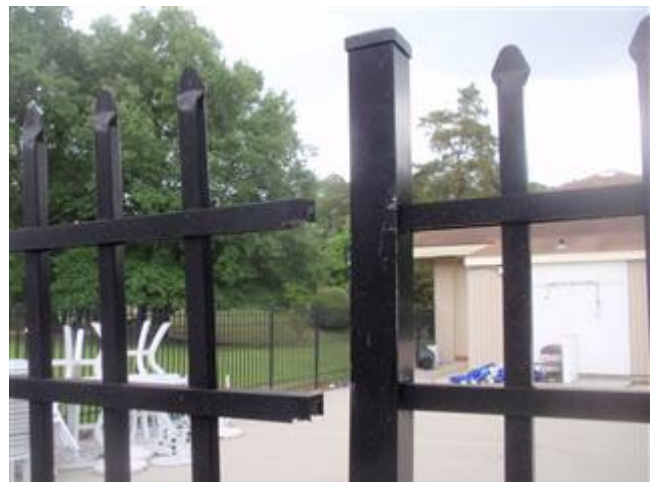
- **Pool Fences.** The pools have aluminum picket railing fences that are in mixed condition. The fences display small areas of damage from either vehicles, groundskeeping, or trespass/vandalism.

For the last update, the previous Manager indicated that both pools are to have approx. 5 each skimmer replaced. And both pool covers were to be replaced within the year. It is unclear if the skimmers were actually replaced or not.

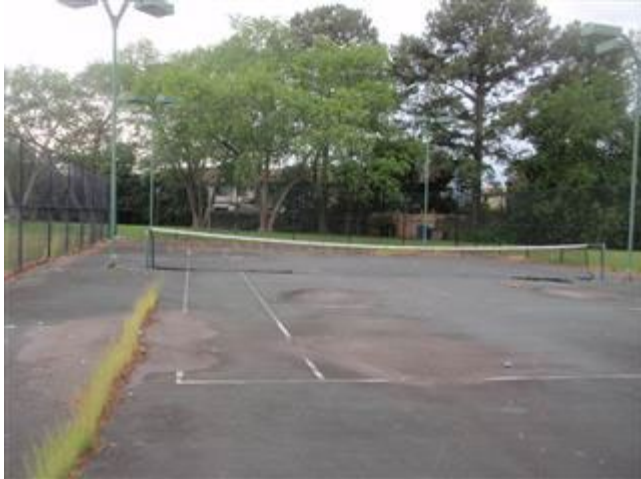
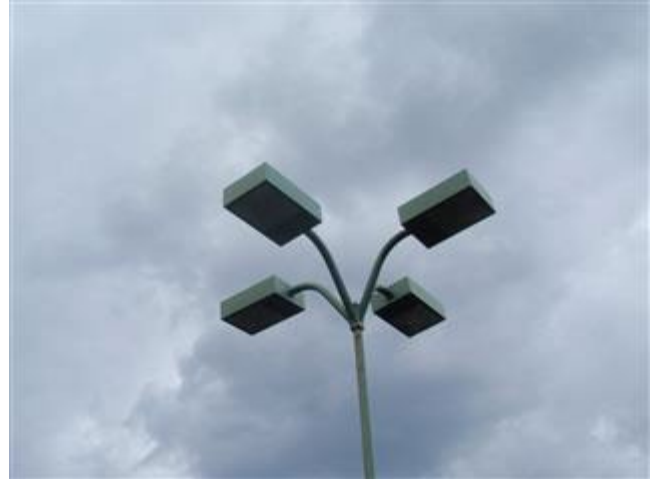
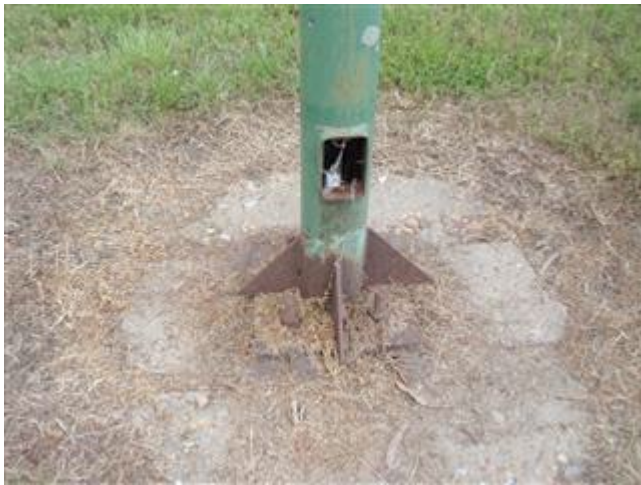
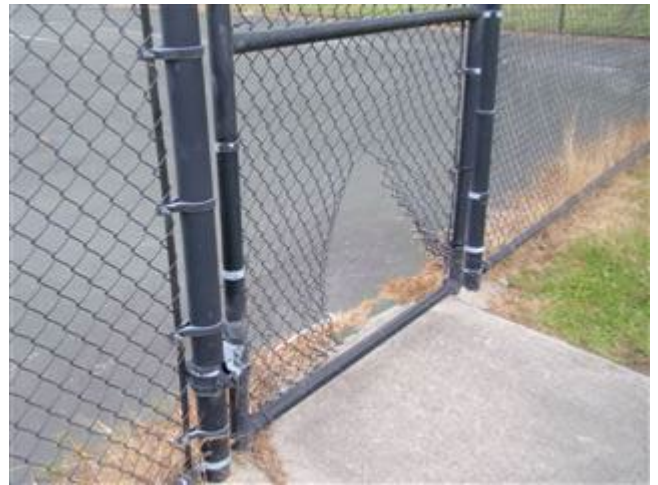
Tennis Courts - Asphalt. The community originally had three tennis courts but previously removed two and now currently retains a single tennis court. This court is repeatedly not used and the overall condition of this remaining court is poor. Despite the replacement of the fence approximately 11-12 years ago (2012) the playing surface and the color coat are showing significant failure from cracking and moisture issues. It is believed that the soils the court is constructed on are unsuitable for proper drainage.

- **Net Posts.** The net posts are in good condition. We have assumed that the new posts will be replaced when the asphalt pavement is replaced.
- **Lighting System.** The tennis court lighting system is reported to be in good operating condition. The bases and poles are displaying corrosion and some of the poles are missing wiring cover plates. There are far more poles and fixtures than needed for the single court because there were originally three courts. Some consideration should be made for removing some of the poles and fixtures in lieu of replacement in the future.

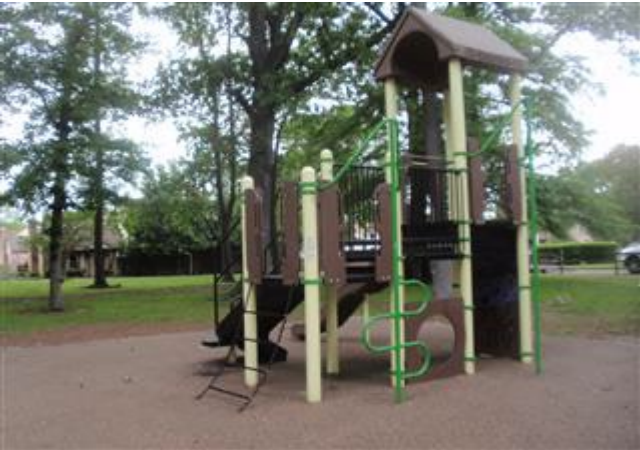
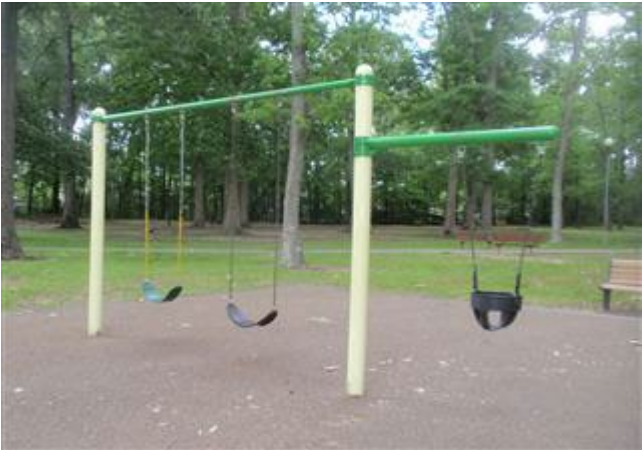
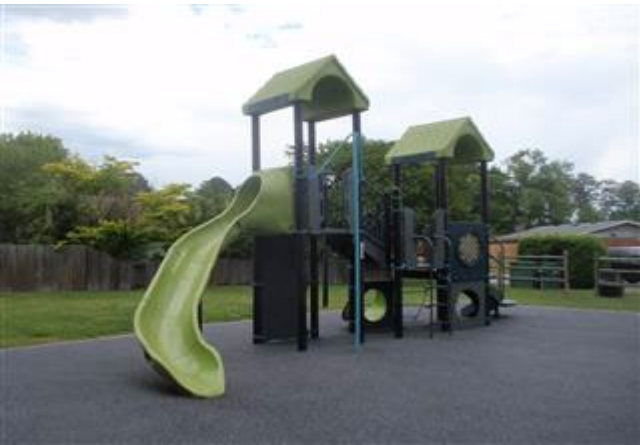
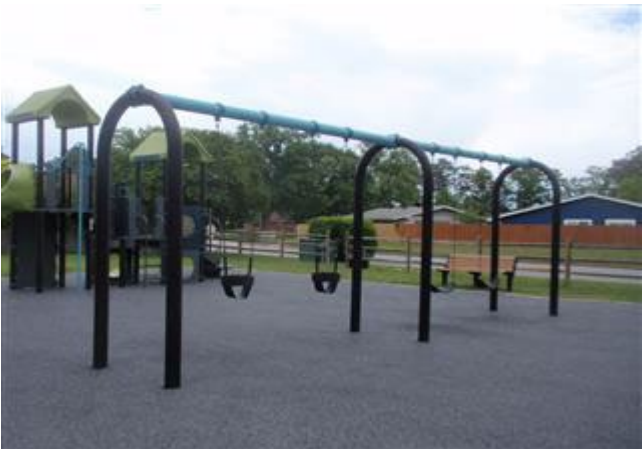
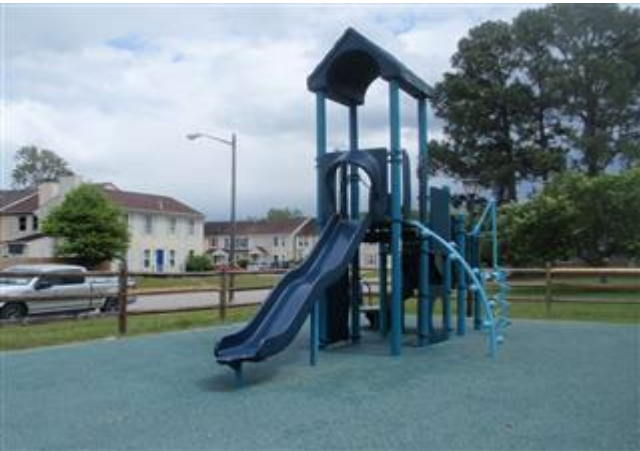
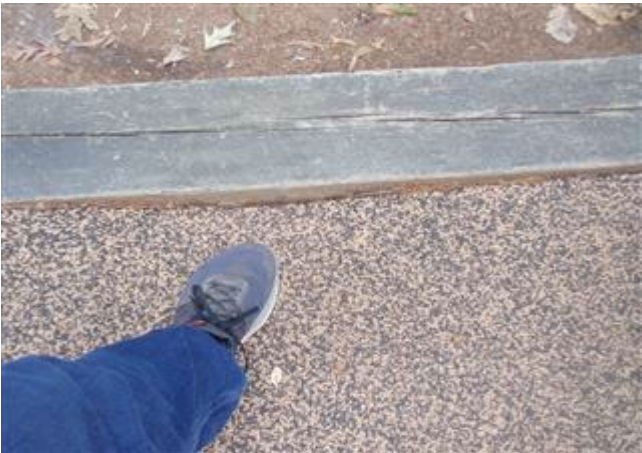
Tot Lots. The community currently maintains 3 tot lots. Two previous tot lots have been removed and are not planned for replacement. The three tot lots have all been fully replaced in the past 6-8 years and use new modern play structures, miscellaneous play equipment, wood borders, and a poured rubberized fall surface. The facility facilities are in generally fair to good condition with no visible wear damage or loose connections for the equipment and apparent vandalism on several components. Portions of the timber borders display deterioration and portions of the rubberized fall protection have holes or early signs of failure. Contact the manufacturer of fall protection for guidelines on maintenance and repair to maximize the life of these materials.

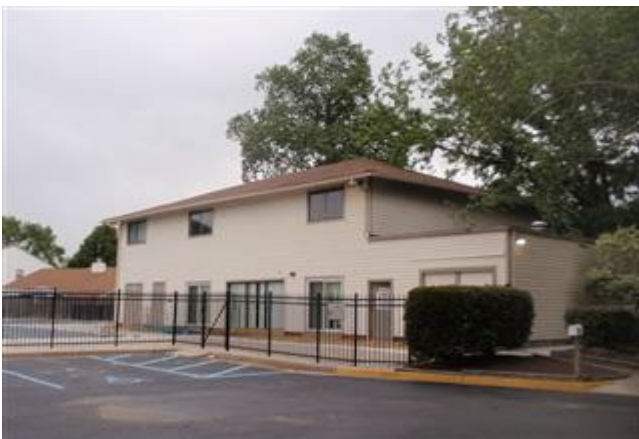
Windsor Oaks Club House. The Windsor Oaks Club House is a two story building with an asphalt shingled gable roof over the two story portion and a smaller one story low sloped roof with a single ply membrane. The shingle roof displays some wind damage including missing shingles. The exterior is clad with vinyl siding. A portion of the exterior doors are in poor to marginal overall condition. The pool to the pump room is damaged and the frame displays wood rot. Sliding doors and windows are in poor to marginal condition and are essentially at the end of their normal life expectancy. Replacement of exterior doors and windows should be anticipated within the next year.

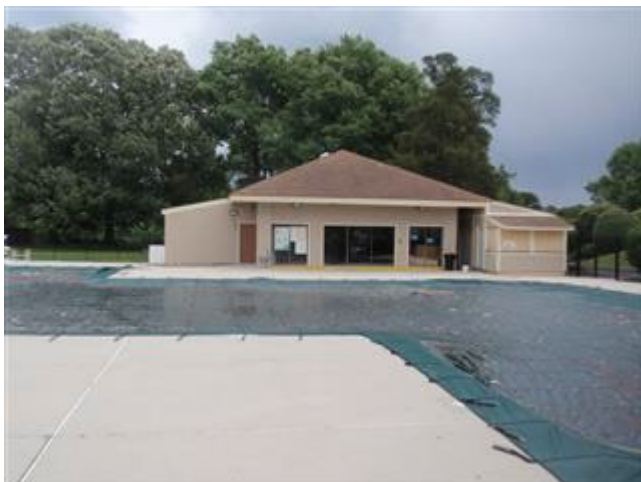
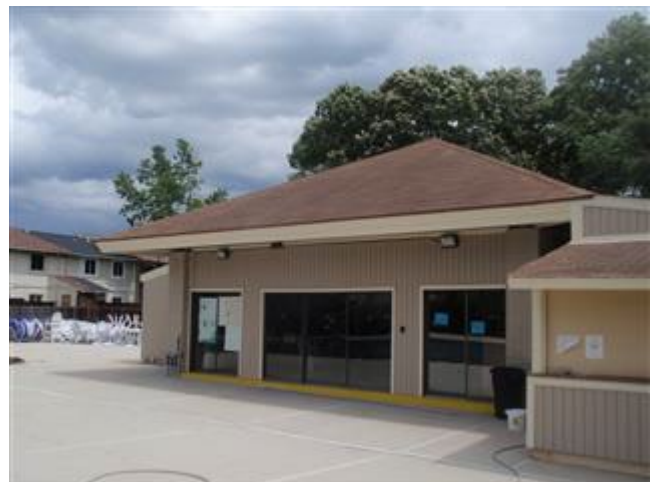
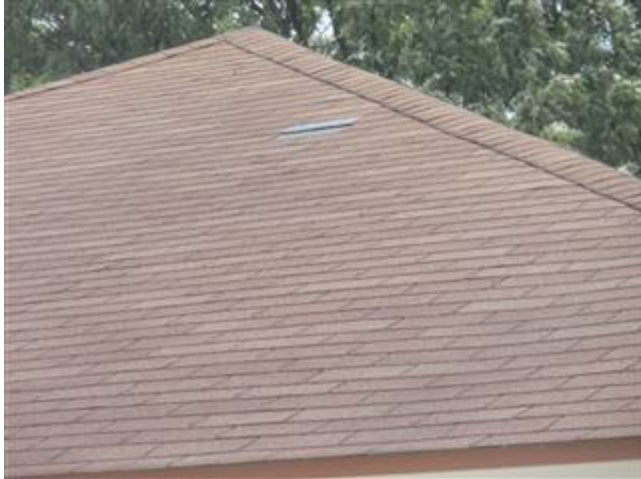
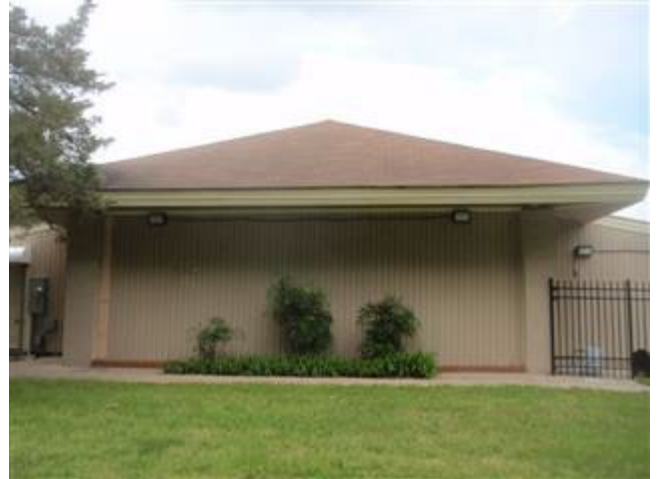
Foxwood Recreation Center. The Foxwood pool house is a single story building with one large community room, and smaller adjoining rooms providing toilets, storage, pool equipment and support spaces for life guards. The exterior roofing is predominantly asphalt shingle roofing and some smaller single ply membrane roofs. The roof was replaced approx. 8 years ago and remains in fair condition with some noted wind damaged shingles. There is a small amount of brick veneer and the siding is predominantly a painted T-111. Painted wood trim, fascias, and soffits are in varying condition. Doors and sliding doors are in marginal to poor overall condition based on original quality and current age. Replacement of exterior doors within the next 1-2 years should be anticipated including the sliding doors and the hollow metal doors. The overhead door appears to be in fair condition.

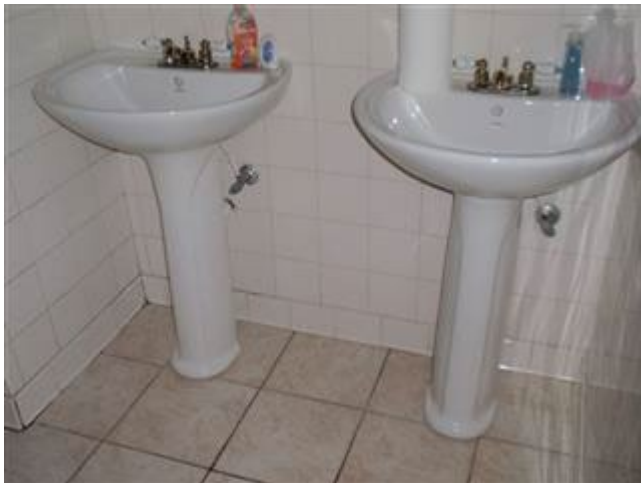
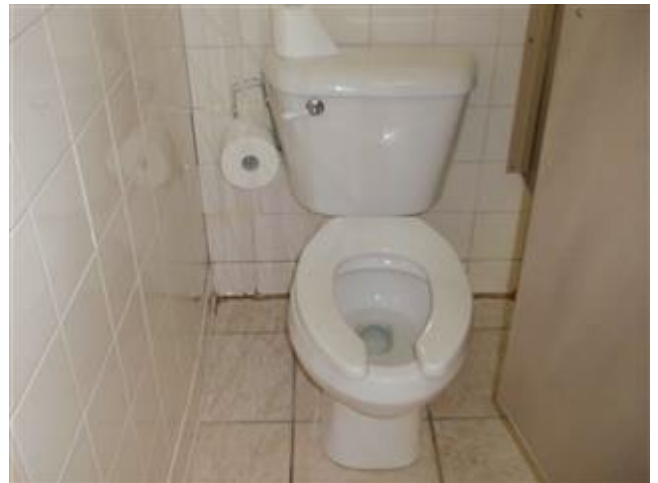
Plumbing. The two recreation centers have modest plumbing comprised primarily of toilet rooms. The fixtures are of different ages in each building as the Windsor Oaks facility restrooms were updated in 2013. The Foxwood toilet facilities have not been modernized. The Windsor Oaks hot water heater and janitor sink appear to have been replaced but the kitchen sink and water fountains do not appear to have been replaced. All of the fixtures in the Foxwood facility should be modernized as current repairs are required or are being performed.

Individual plumbing fixtures can be replaced as needed using operating funds.

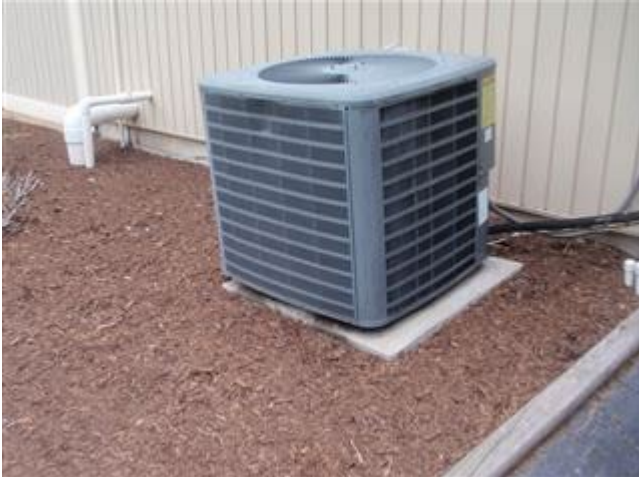
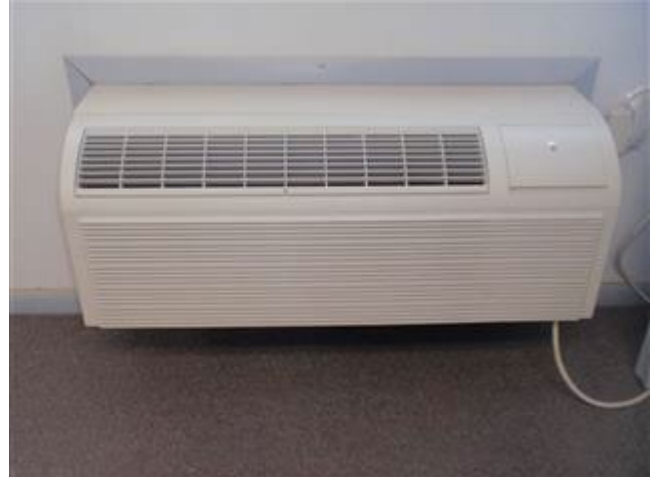
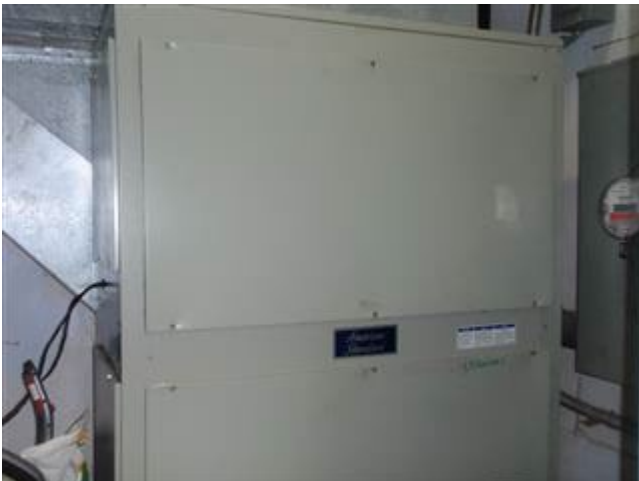
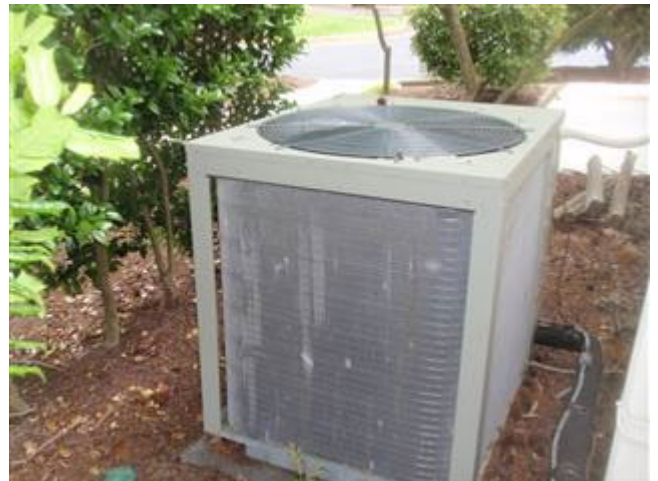
HVAC Systems. The HVAC unit for the Foxwood Recreation Center was replaced in the past 7 years and appears to be in good working condition. The Foxwood building is generally used only during the pool season. The building is reportedly seldom used except for the swim club and the system is not zoned or on an automated controls system. The HVAC unit for the Windsor Oaks Recreation Center is currently working but is believed to be original and is clearly beyond the normal life expectancy. Because of the antiquated age of the Windsor Oak system, it is recommended that it be replaced in its entirety to include a higher efficiency system properly sized and zoned to improve the energy consumption for the buildings under their normal seasonal occupancy and use. The Windsor Oaks building was previously used by office staff year round and is rented out on weekends which requires very different heating and cooling conditions throughout the year. Consider multiple units for zoning to reduce the energy consumption of a building-wide unit.

The two upstairs offices have Packaged Terminal Air Conditioning (PTAC) units.
